STATE OF CALIFORNIA  
DEPARTMENT OF PUBLIC WORKS  
DIVISION OF HIGHWAYS

CUT SLOPE DESIGN AND LANDSLIDES  
SOME CASE HISTORIES

T. W. Smith and H. R. Cedergren

Prepared for  
A.S.T.M. Meeting  
Los Angeles

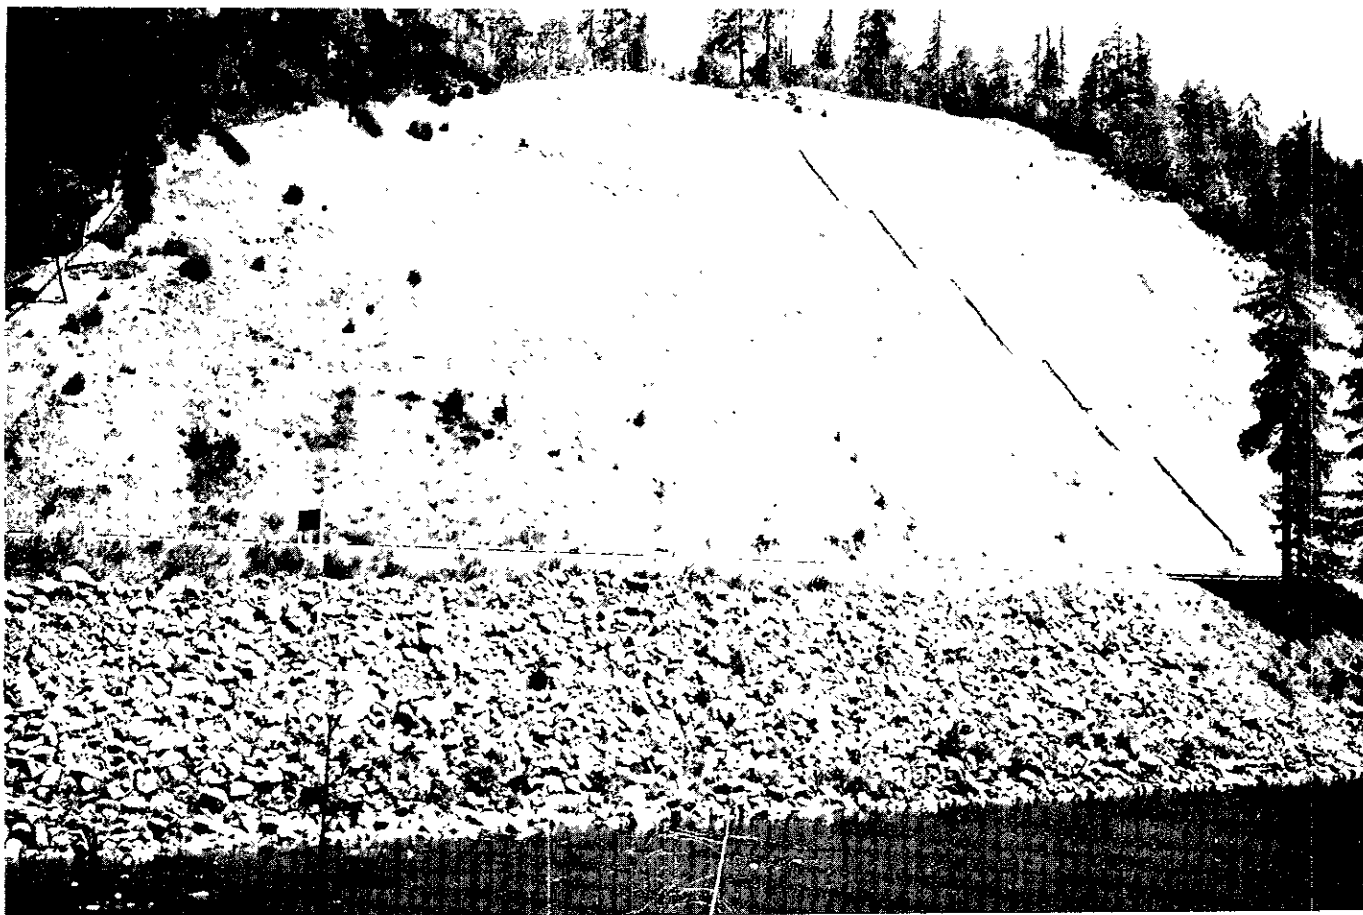
This cut was constructed according to plans and the job was accepted as complete on November 12, 1958. It has passed through four winter seasons without any signs of instability. Considering the great height of this cut, this project has been very satisfactory. The exploratory borings indicated that there would be no significant changes in material except for the top soil and degree of weathering for the depth that was to be removed, and that the new slope would be in the same kind of

Fig. 1 - View of Completed Dyerville Cut

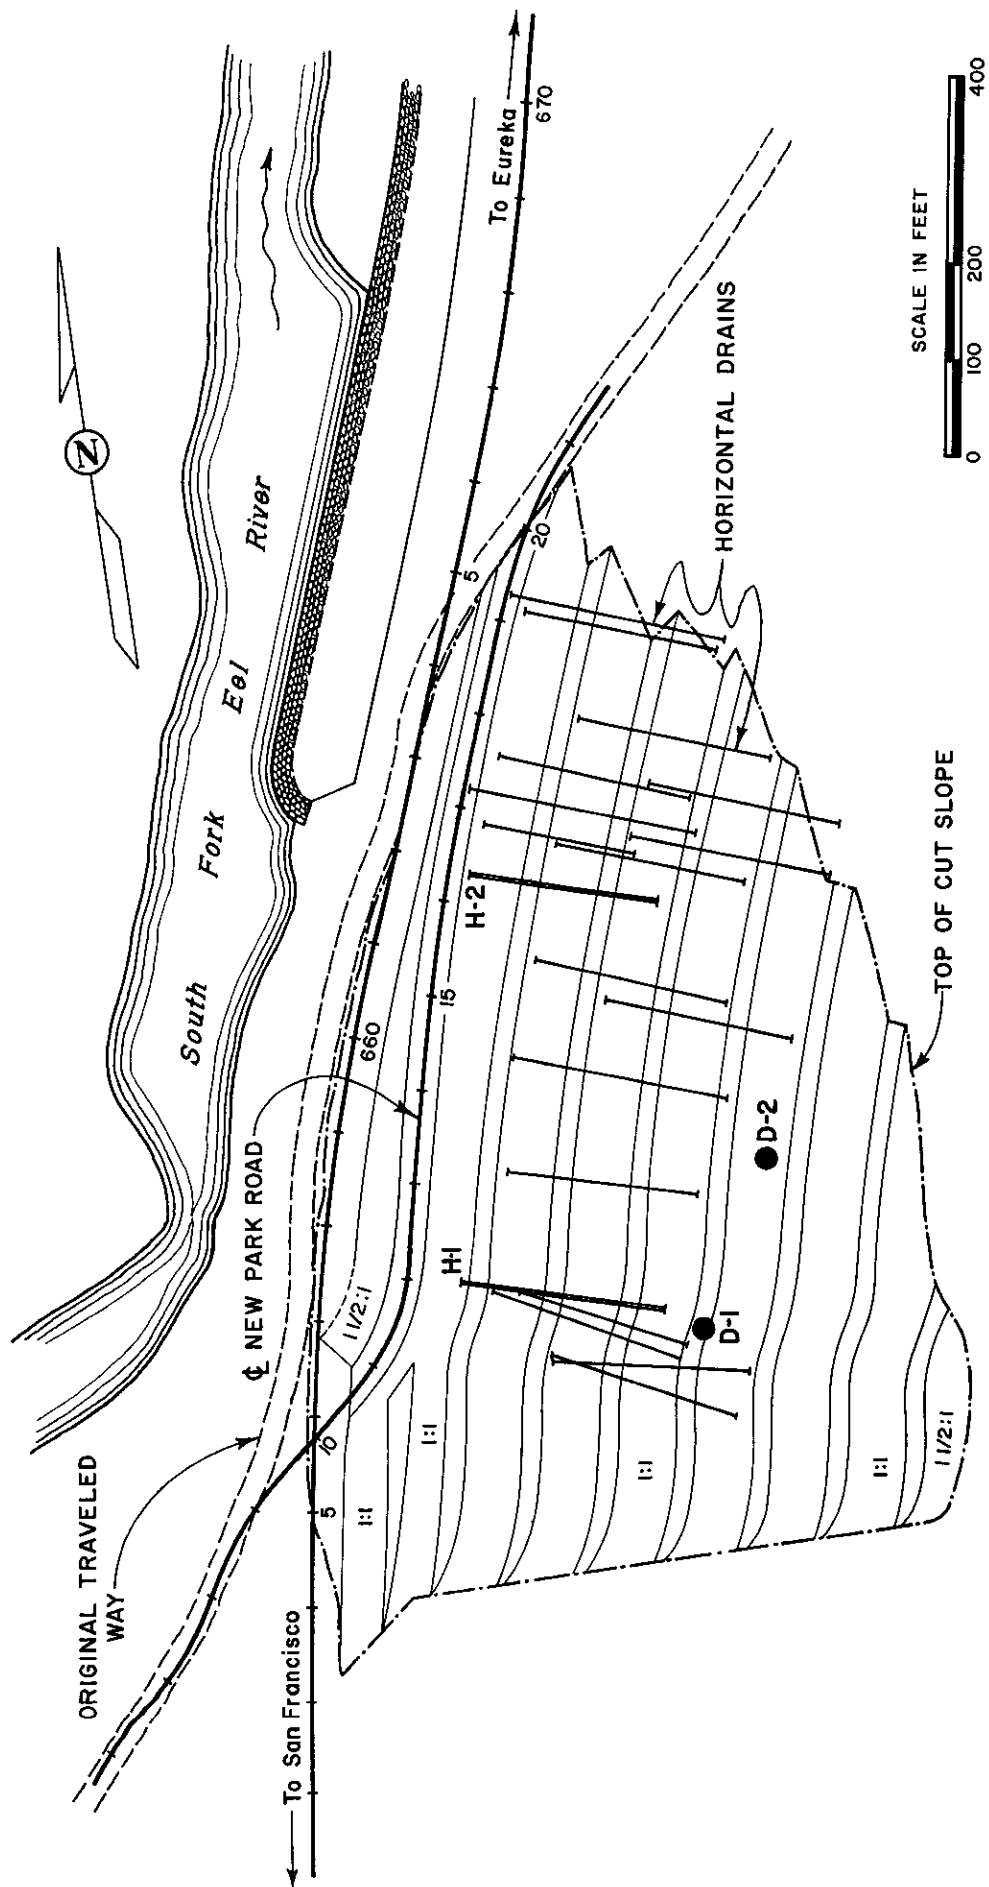
A plan of the cut area is given in Fig. 2 and a typical cross-section in Fig. 3. The locations of the borings are shown on the plan. Their logs, in simplified form, are given in the cross-section sheet. The horizontal boring (H-1) furnished useful information; however, it penetrated the hill nearly parallel to the dip and gives a distorted picture of the thick-

FIG. 2 PLAN OF DYERVILLE CUT SHOWING  
HORIZONTAL DRAINS AND BORINGS

In view of the great height of this cut the recommended design called for 1:1 slopes with 20-ft. benches at 60-ft. vertical intervals. This design produced a slope roughly parallel to the slope that existed before this cut was excavated. The cut is "side-hill" and involved the slicing off of a 60- to 80-foot thick prism of earth from the face of the slope. To insure a reasonable margin of safety during periods of high ground water, more than 3000 linear feet of horizontal drains were installed in this cut. A pervious blanket, and underdrains with perforated metal pipes were installed below the roadbed for the protection of the structural section from excess ground water.

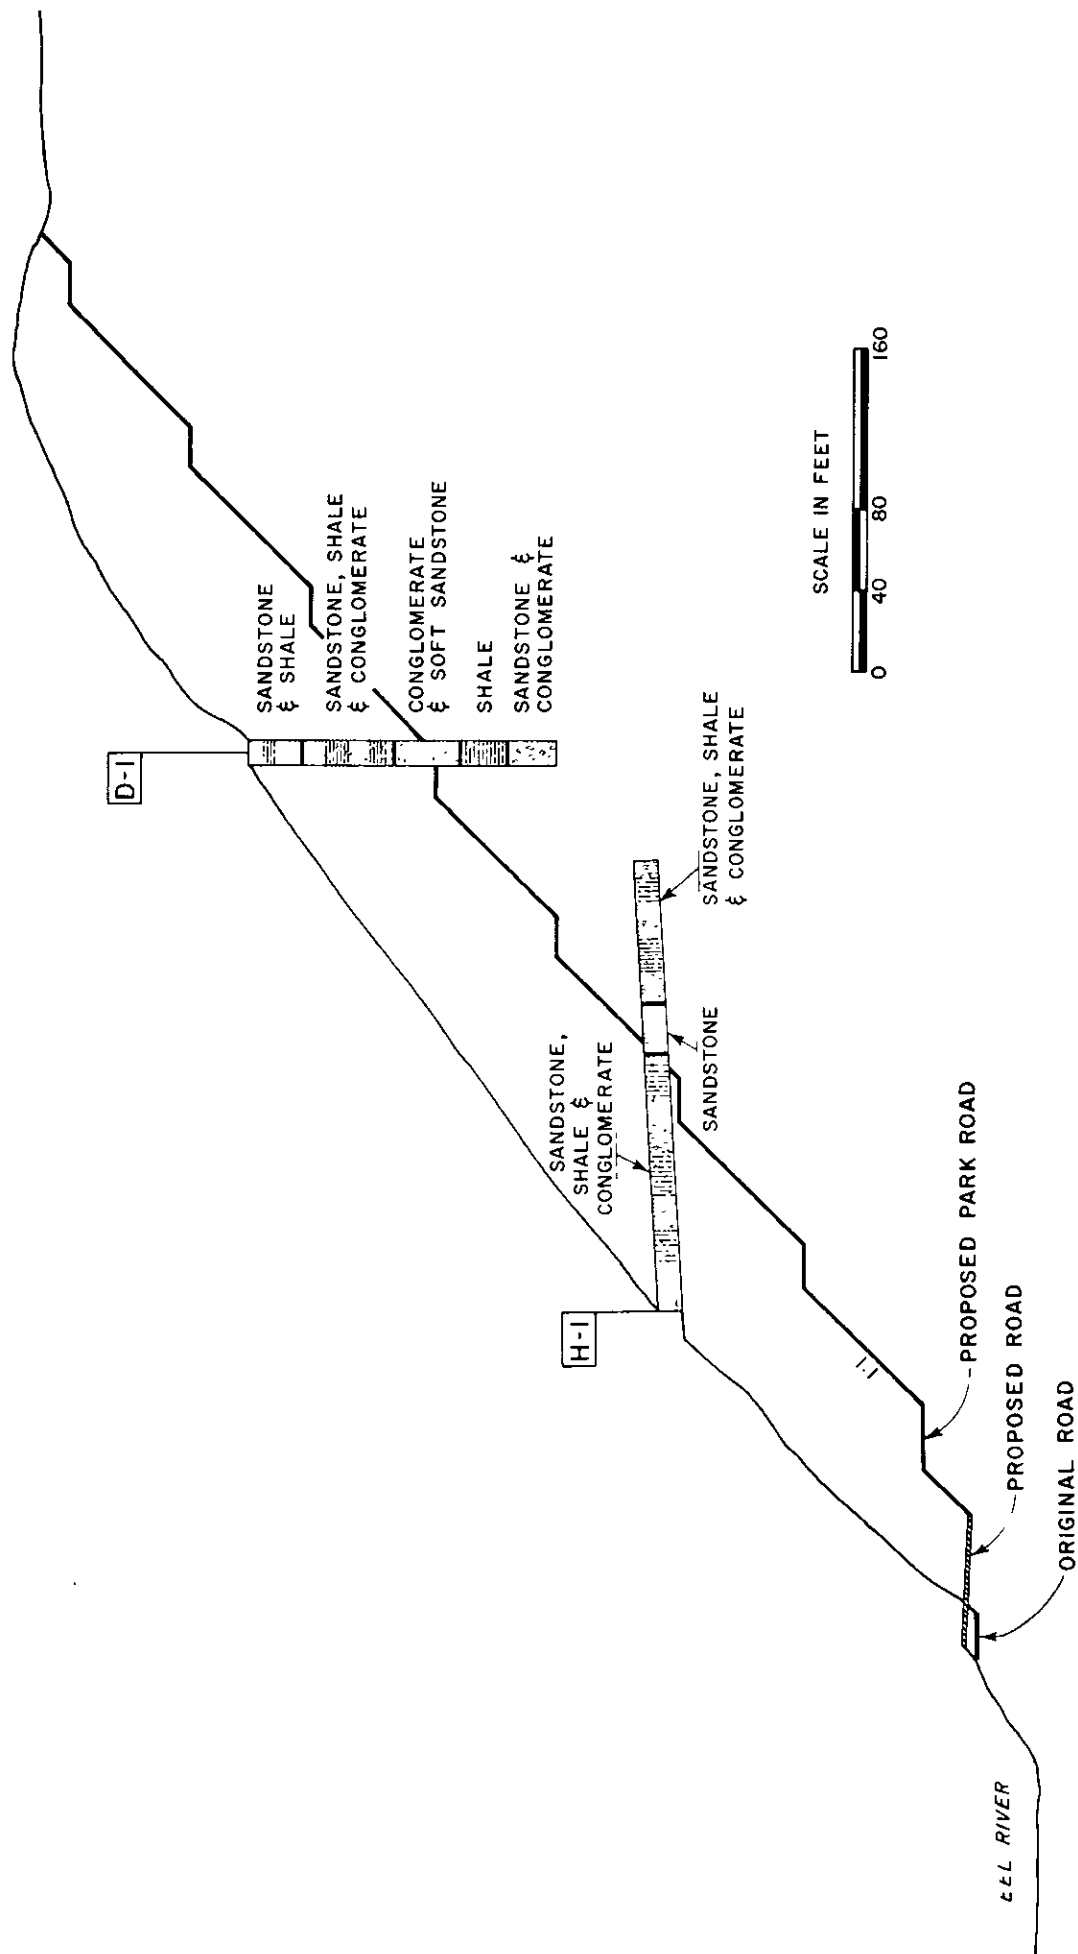
FIG. 3 TYPICAL SECTION OF DYERVILLE CUT SHOWING  
BENCHED DESIGN AND SIMPLIFIED BORINGS

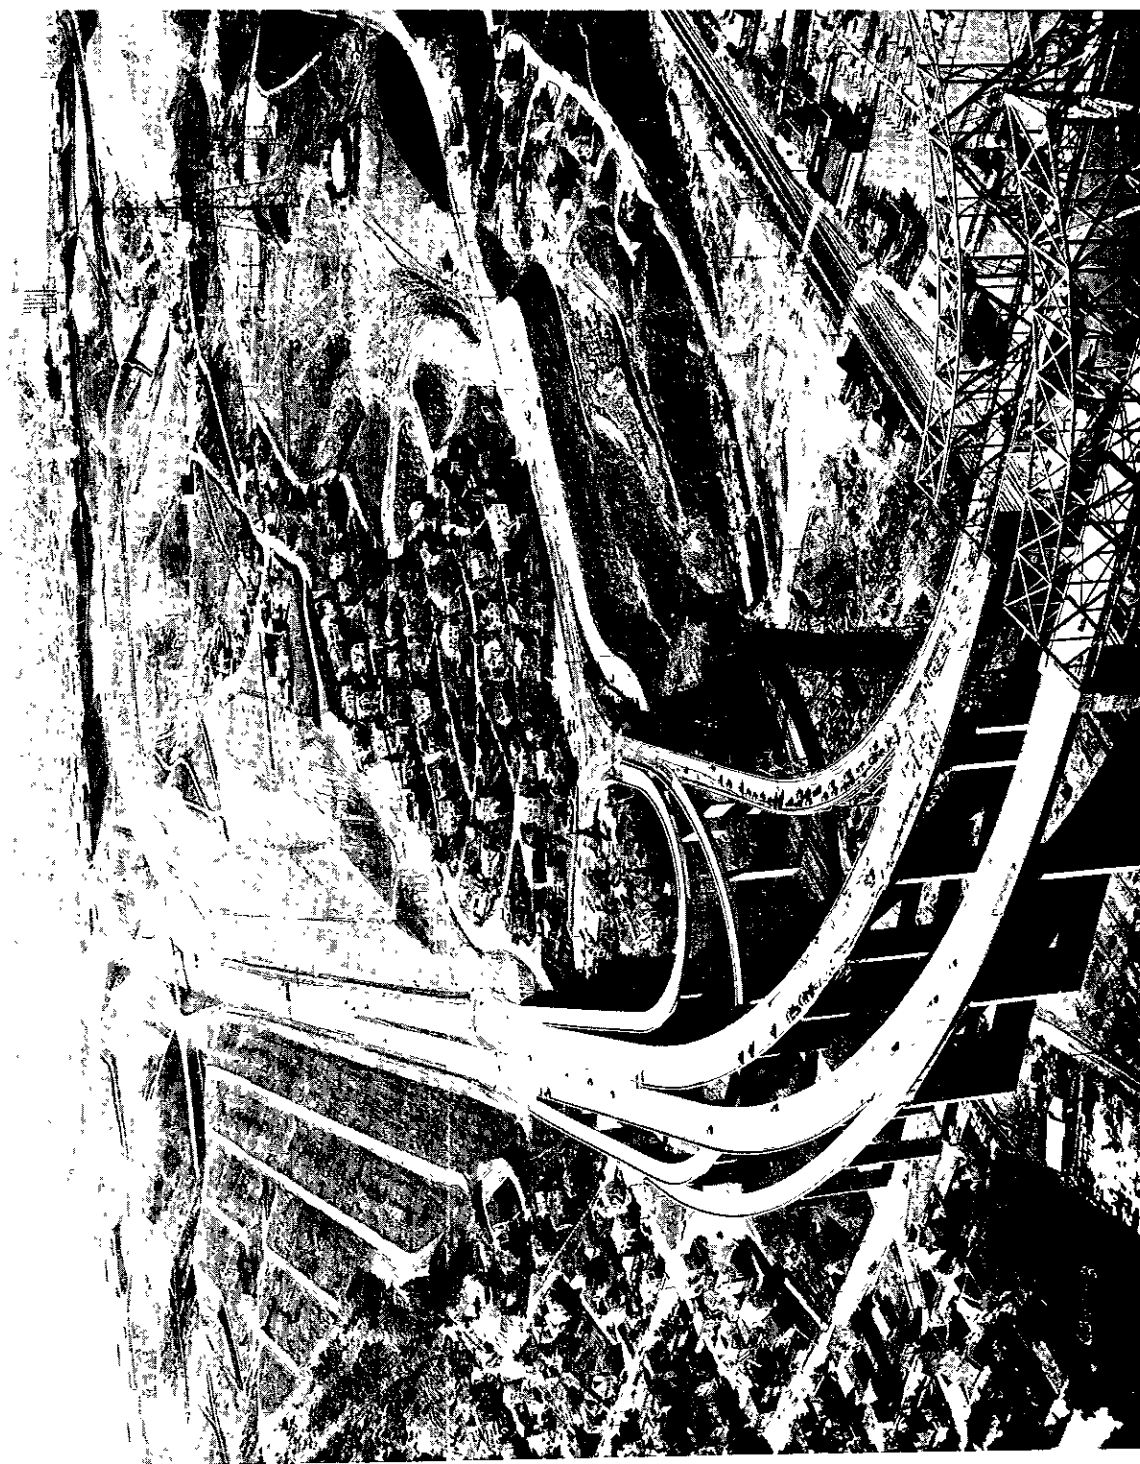
the designed and constructed slopes have been stable. From time to time small slides have occurred at various points on the faces of the cuts. One slide of rather major proportions took place at the north end of the cut in an area known locally as Valona. The extent of this slide in relation to the magnitude of the cut may be seen in the photographs reproduced in Figs. 4 and 5.

Fig. 4 - Aerial View of Completed Carquinez Cut and  
Southern Approach to Twin Bridges

In February, 1958, some cracking was observed above the cut in the area on the west side of the cut, noted above. Subsequently, a retaining wall was badly cracked and noticeable cracks showed up in the basements of two of the houses at the top of the slope. The condition got progressively worse, and several houses had to be removed and the slide mass removed. After this treatment this area showed no further evidence of instability.

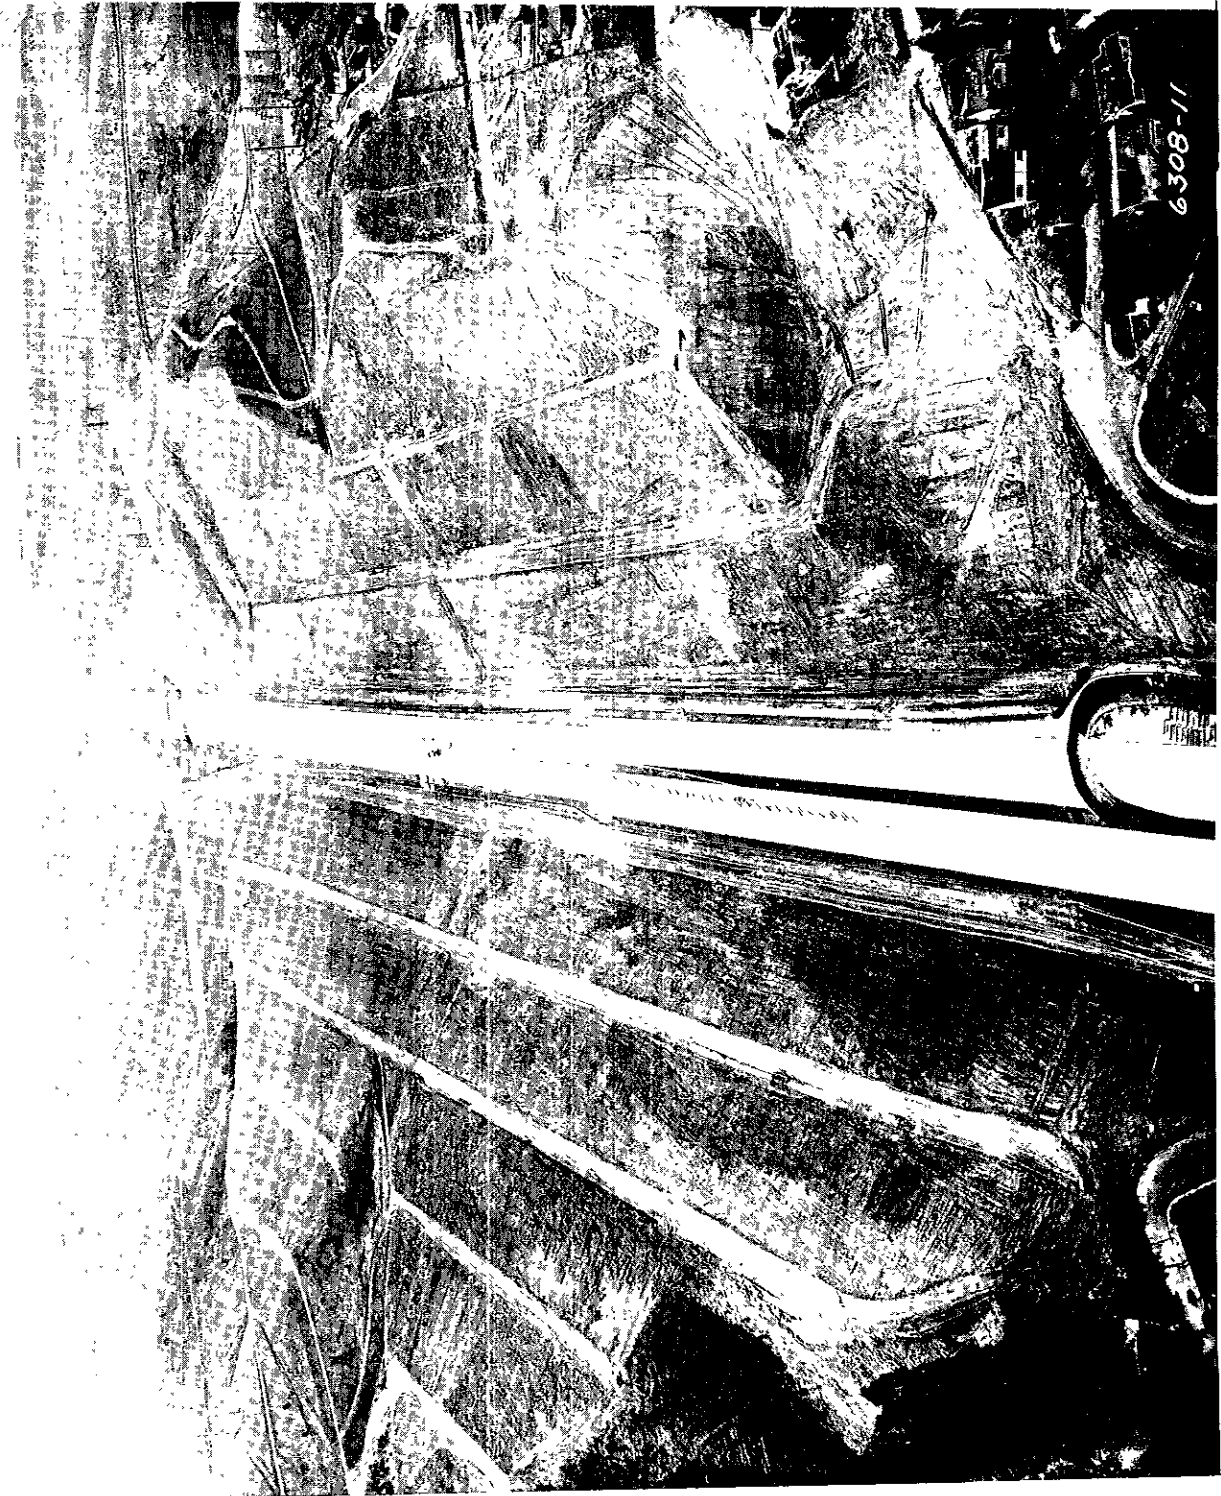
Fig. 5 - Aerial View Showing Magnitude of Carquinez Cut

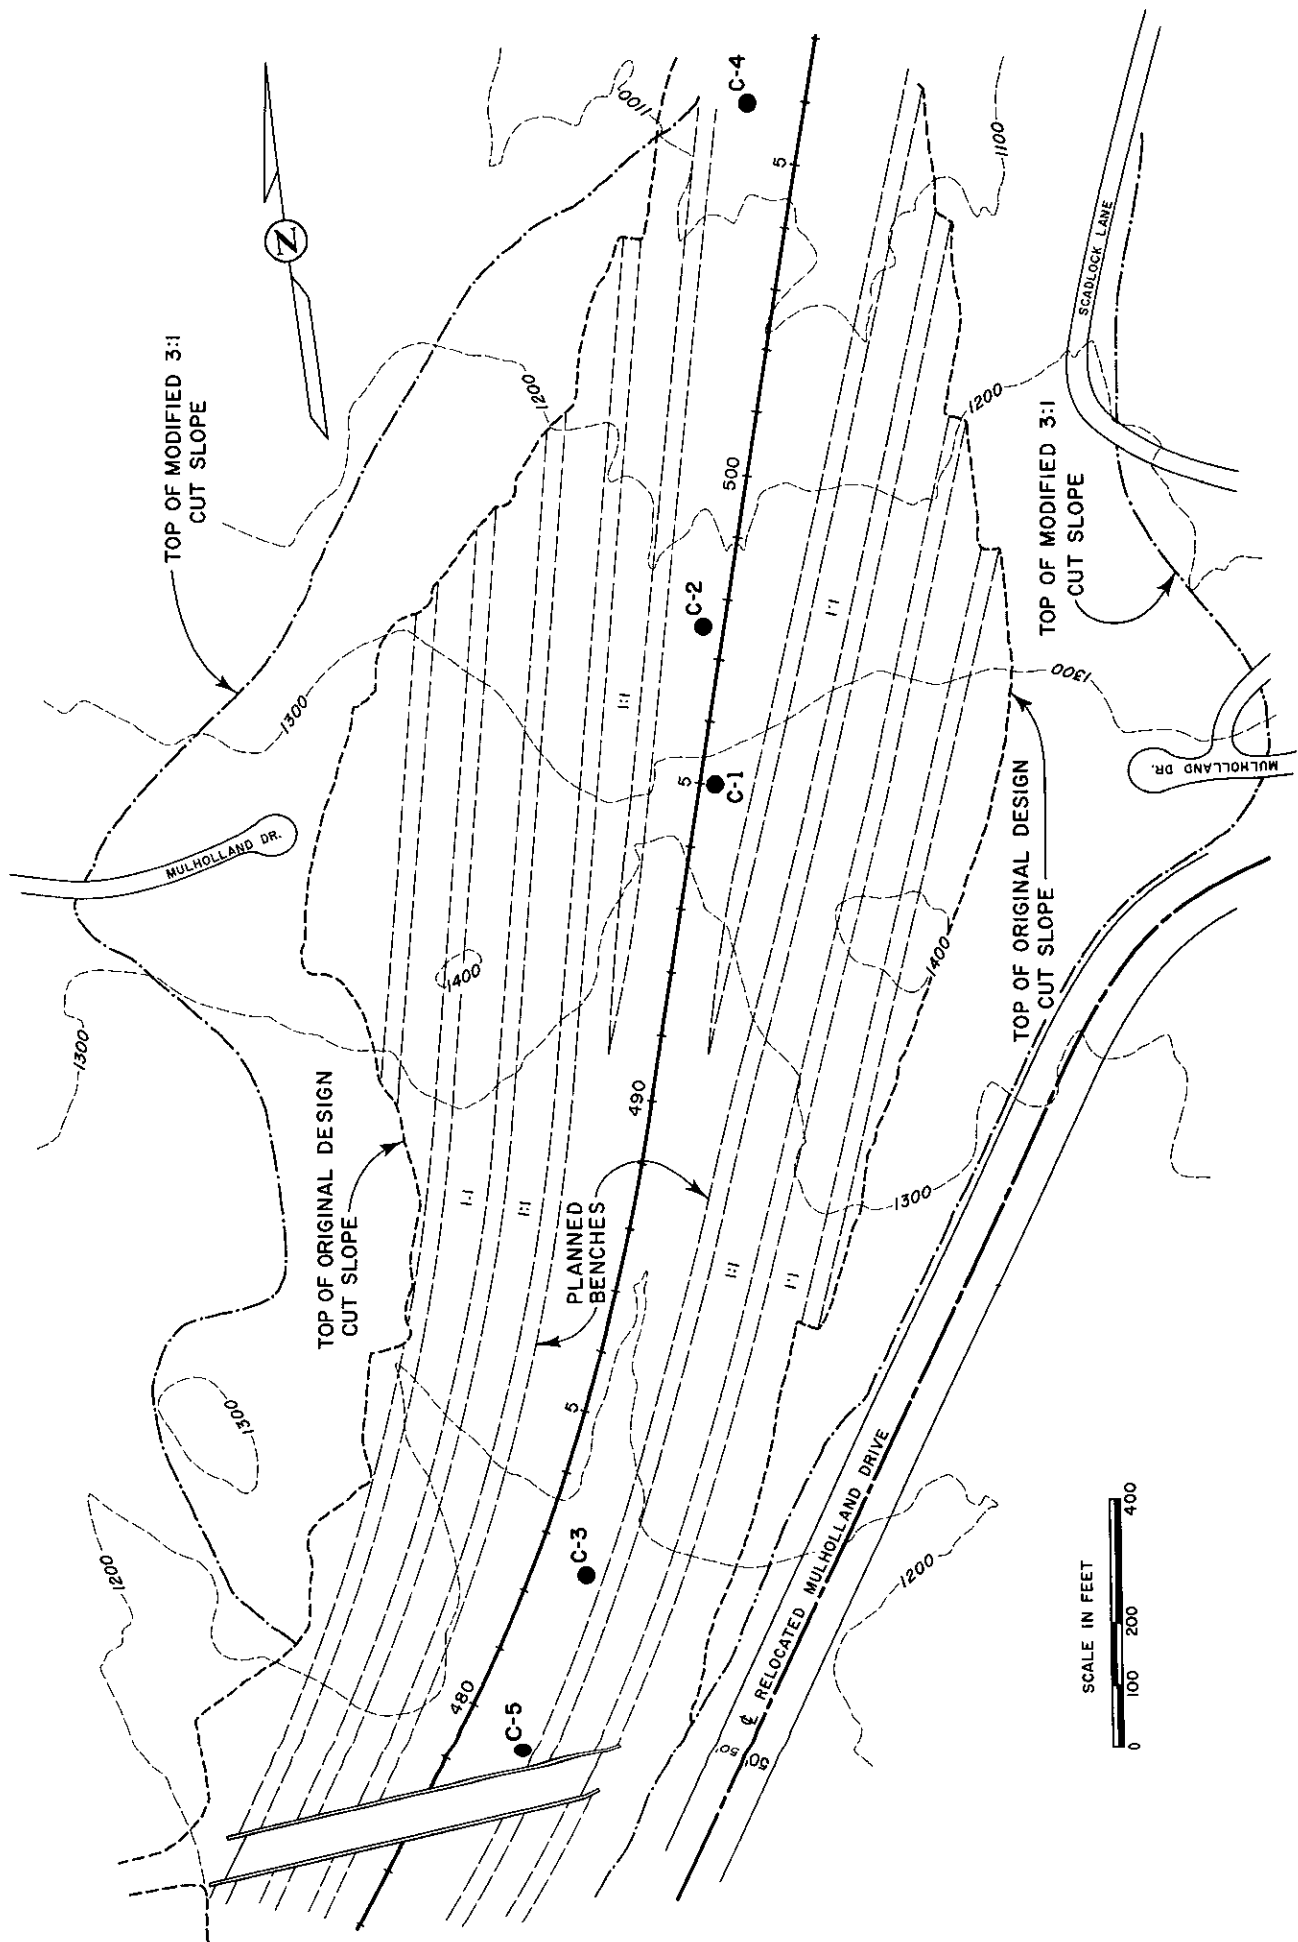
In 1955, starting August 11, five borings were made in this cut area. The locations of the borings are shown on Fig. 10. A simplified log is given on Fig. 11. Supplementing the data obtained in the actual drilling operations were electric logs of all of the borings. The foundation conditions are illustrated by an abbreviated summary of hole C-1. The upper 100 feet consisted of beds of firm shale of variable thickness and loosely

FIG. 10 PLAN SHOWING ORIGINAL AND MODIFIED SLOPE DESIGN OF MULHOLLAND CUT

After a review of the boring logs and the geological history of the area, it was recommended that this cut be constructed with  $1\frac{1}{2}$ :1 slopes with 30-foot benches at 60-foot vertical intervals. Subsequently a large excavation was made in this area to obtain borrow for another highway project. This excavation stood on a 1:1 slope without any serious failures. It was then decided that the Mulholland cut could be designed on 1:1 cut slopes benched at 60-foot vertical intervals.

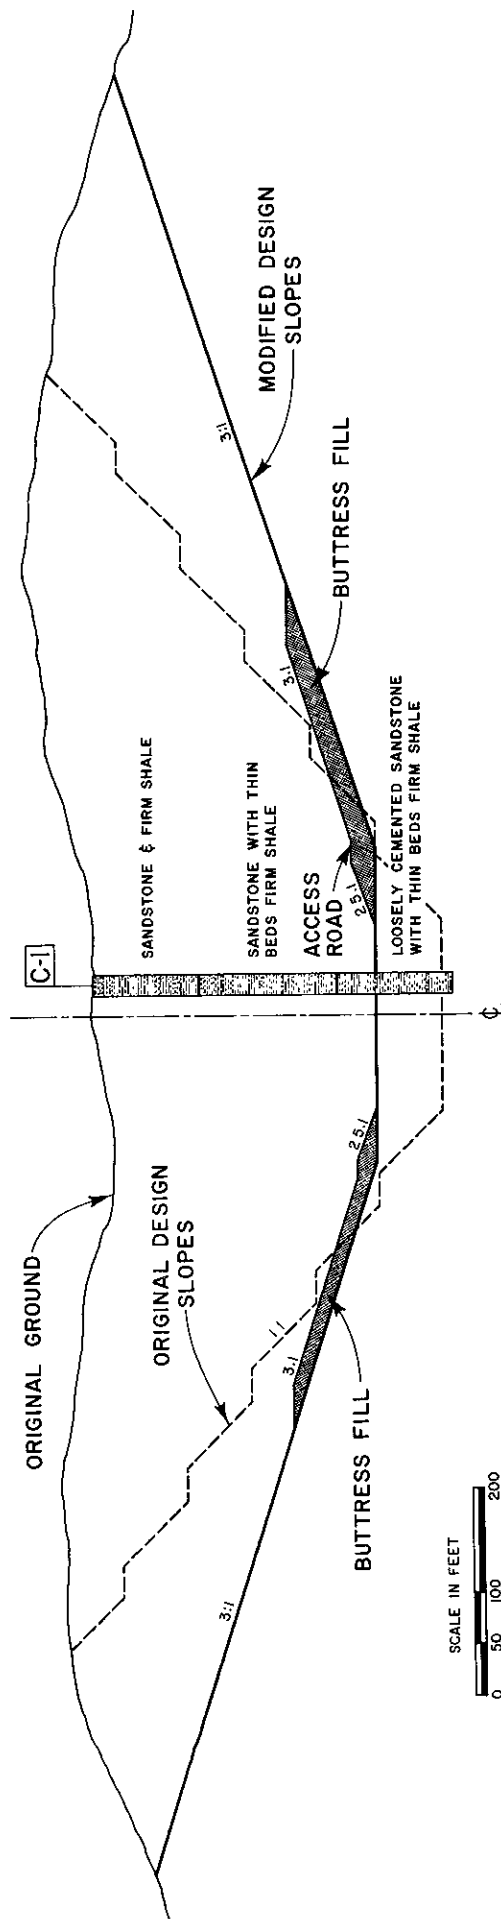
to moderately cemented sandstone. The next 100 feet was made up of loosely to moderately cemented sandstone with an occasional thin bed of firm shale. From 200 feet to the bottom of the boring (333 ft.) the materials consisted of laminated firm shale and loosely cemented sandstone. The dip of the formations generally was  $15^{\circ}$  to  $20^{\circ}$ , and the strike was generally normal to the roadway. The water table was recorded 120 feet above the proposed grade in this boring. In general the sandstones were softer than had been anticipated from preliminary investigations, but appeared to be relatively stable. Slight variations in the strike resulted in a slight dip, less than  $3^{\circ}$ , into the roadway prism in the vicinity of Station 501 to 502.

FIG. II TYPICAL SECTION OF MULHOLLAND CUT  
SHOWING ORIGINAL AND MODIFIED DESIGN

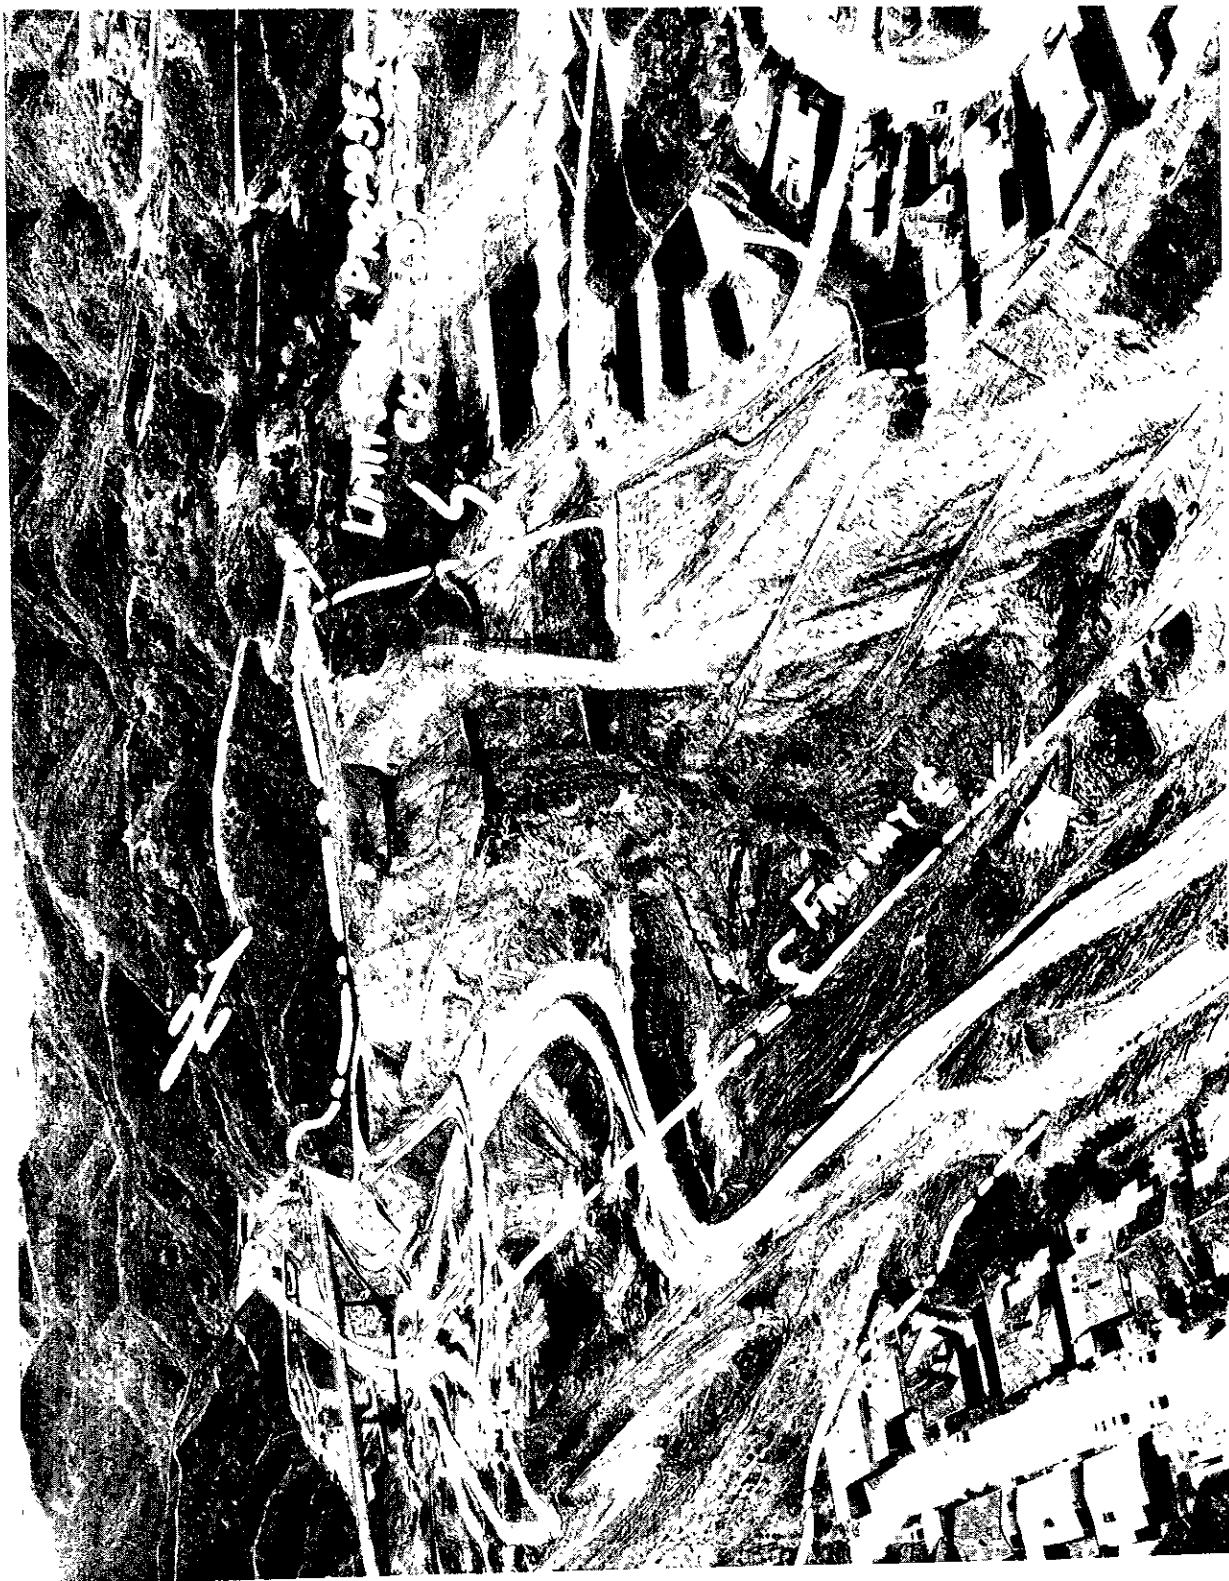
Local slides of a minor nature developed during early progress of this contract, getting progressively worse as the excavations progressed. By October, 1961, cracking developed on the east side of the Mulholland cut which forced the owner of an adjacent home to leave his home on Scadlock Lane. Additional cracking in the street and adjacent properties on the west side of the cut indicated a slide potential of major proportions. Accordingly, the contractor suspended operations in this portion of the cut and moved his equipment to higher ground.

Minor cracking had occurred in the east side of the cut as early as July 1961, but this was not considered serious until early in October when cracks began to develop in the floor slabs of the private dwellings on Scadlock Lane, as noted above, and more definite cracking occurred through the contractor's yard and in the pavement of old Mulholland Drive. The extent of the slide may be seen in the photograph in Fig. 12. To aid in analyzing the geological conditions and the slide movement, a geological model was constructed (See Figs. 13 and 14).

Fig. 12 - Aerial View of Mulholland Showing Failure of  
Partially Completed Cut and Limits of Modified  
Cut Slopes

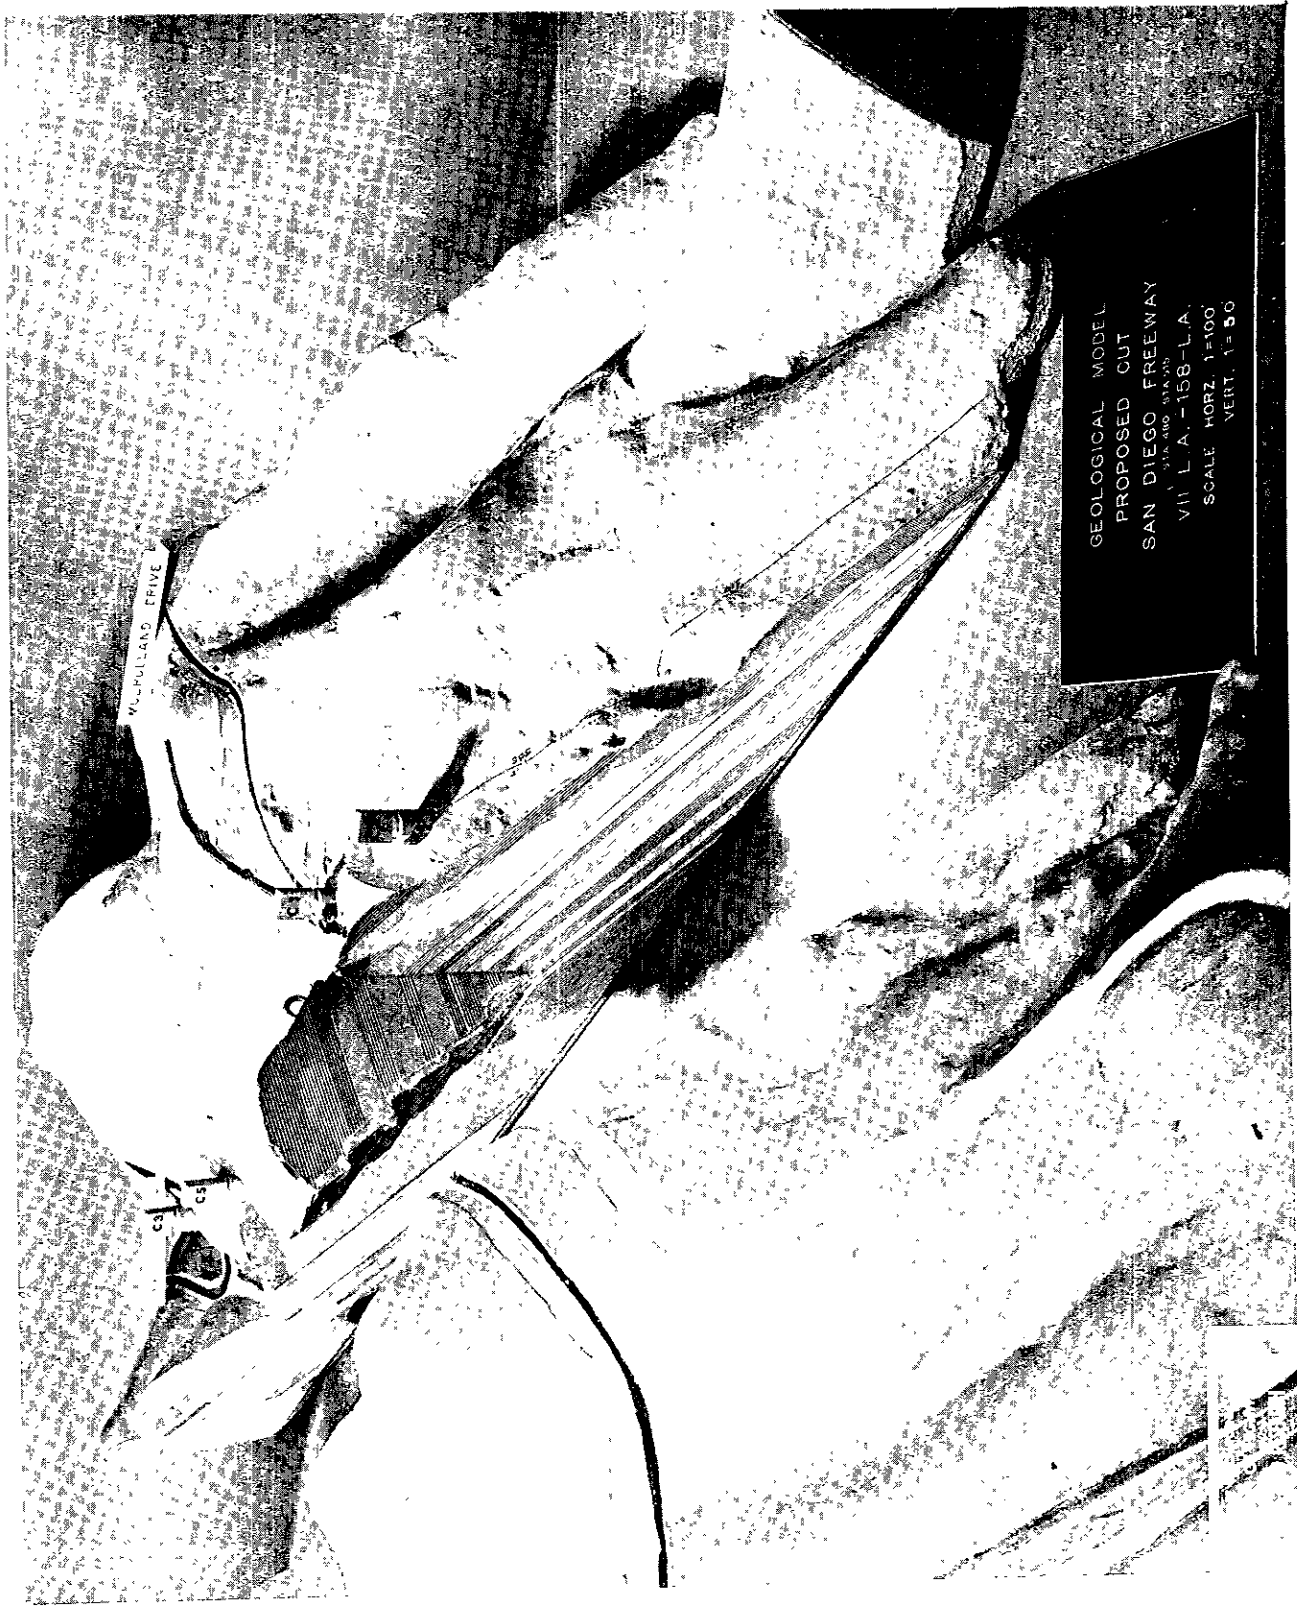
Fig. 13 - Photograph of Model Separated to Show Geologic Formations at Site of Mulholland Cut

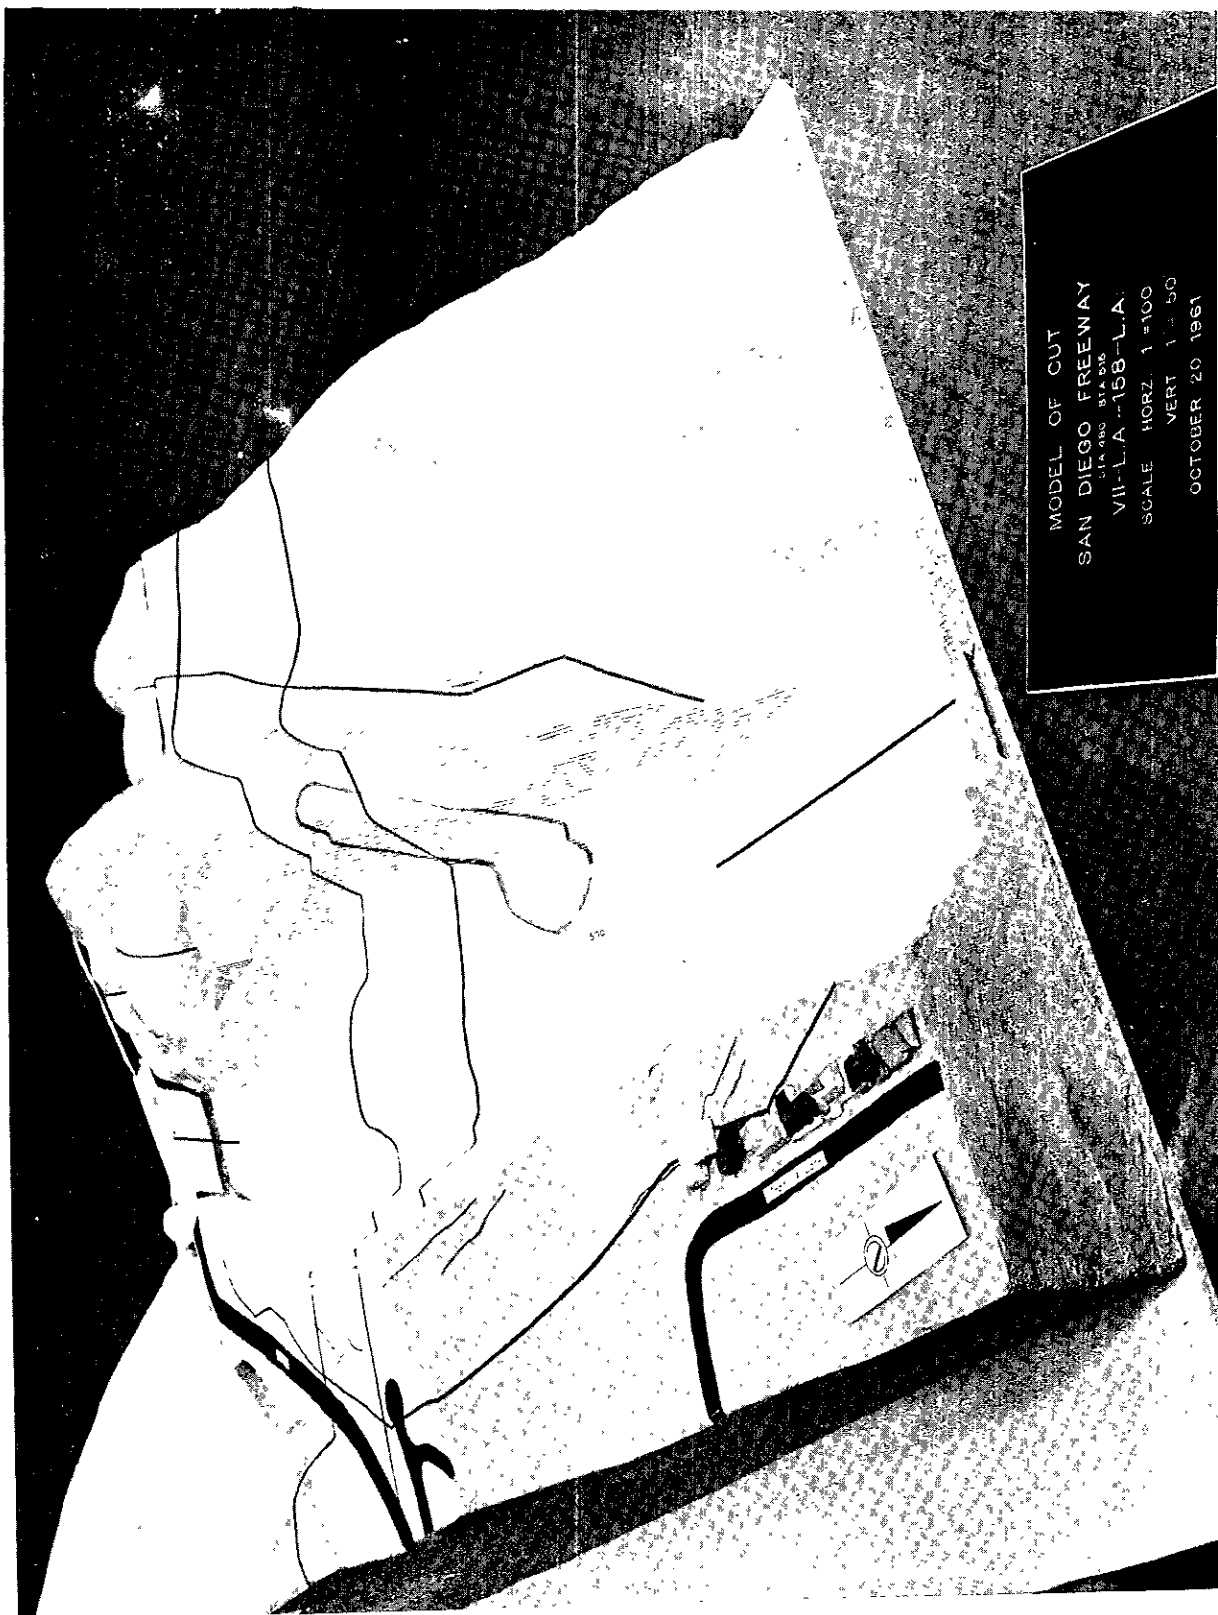
A series of investigations by the District Office, Headquarters Materials and Research Department, and consulting engineering geologist, Dr. Arthur Cleaves, was conducted late in October, 1961. These investigations indicated that the slide movement was in the form of a block glide, the slippage

occurring on the gently dipping siltstone bedding planes that sloped toward the excavation. A study of this slide indicates that it probably was caused by a combination of factors, of which the following are believed most important: (a) a slight dipping of the formations into the roadway excavation, (b) the relief of stresses within the earth masses caused by the unloading, and (c) the breakdown of shale into clay by the slide movement, producing very slippery planes. There was nothing observed in the original explorations to indicate that a serious slide potential existed. The stresses set up by the tremendous earth mass evidently exceeded the strength, which caused the movement to start, setting off the cycle described above. Following these investigations a number of alternate corrective treatments were considered including slope flattening, use of buttress fills, raising the grade, shifting the line to the west in conjunction with slope flattening and buttress fills, tunnel construction, and split roadways with steepened grades. Estimated costs of the corrective treatments varied from \$2,500,000 to \$38,000,000 (the highest being for bored tunnels).

Fig. 14 - Photograph of Mulholland Cut Model Showing Status of Excavation at Time of Failure

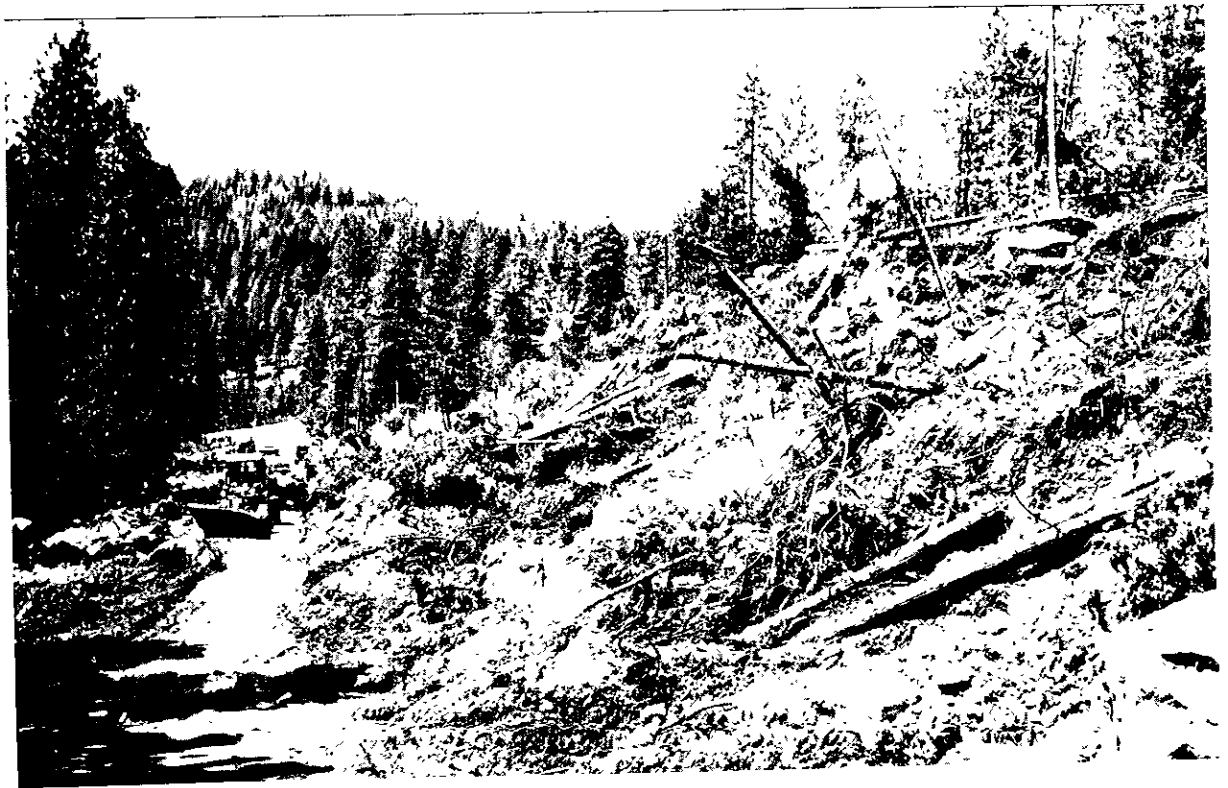
Fig. 16 - View Looking West Along Highway at Toe of Towle Slide
